North Arm Cove Stormwater Management Strategy

Reference: R.N20118.001.04.docx
Date: May 2017

Prepared for: Great Lakes Council

Prepared by: BMT WBM Pty Ltd (Member of the BMT group of companies)

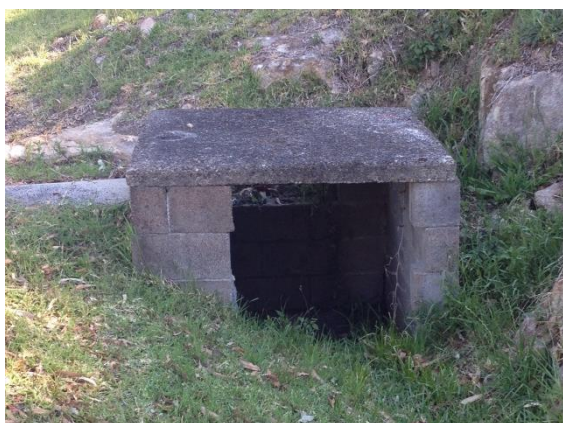
Figure 3-1 Example of hazardous pit inlet opening

A number of existing stormwater pit inlet openings across the study area are too deep and would exceed standards introduced to restrict access to drainage systems by children. Four pit inlets were identified with openings ranging between 0.6m and 0.9m. During large rainfall events, the depth of stormwater able to pond around the pit inlets would be hazardous and particularly dangerous for children.

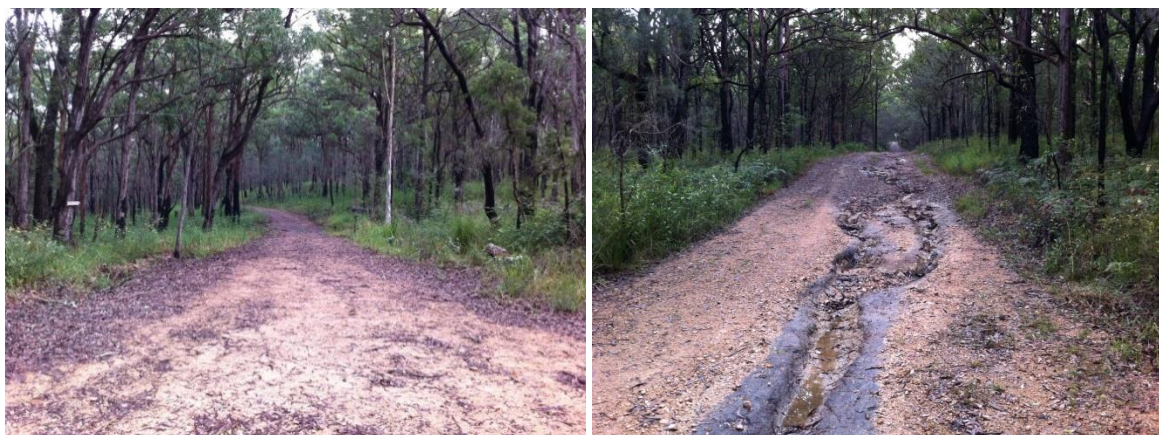
Figure 3-2 Unsealed Fire Trails - aligned along contours (L) and across contours (R)

Figure 3-2 highlights the different conditions of fire trails in the area when trails are aligned along contours (shallow gradients) or aligned across the contours (steep gradients).

Steep unsealed fire trails in undeveloped areas should be regraded to remove deep rills and provide one way crossfall. It is recommended that low contour banks ('whoa boys') be aligned across the road to direct runoff laterally into tailout drains that discharge into the existing bushland.

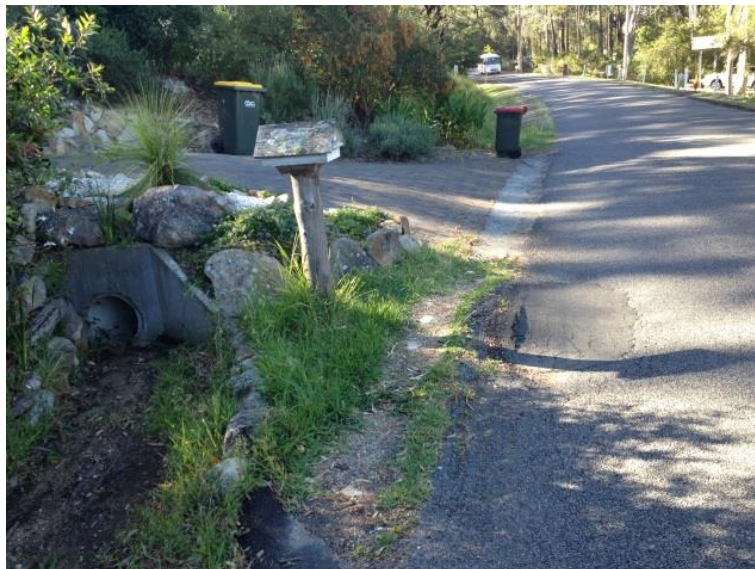
Figure 3-3 Example of Elevated Driveway Crossing

This has resulted in a number of driveways functioning like small dams and diversions, significantly impeding the flow of stormwater. Stormwater backs up behind the driveway crossings at a number of locations, and spills across the road into properties located on the low side of the road. An example driveway is shown in Figure 3-3.

The size of pipe crossings under driveways was also observed to vary significantly. At a number of locations the pipe crossing invert is elevated above the adjacent table drain resulting in shallow ponding of stormwater on the high side of the driveway. This appears to have occurred mainly as a result of poor construction control. However, over excavation of the drains during maintenance has in places caused stagnant water to pool behind driveways encouraging mosquito breeding habitat.

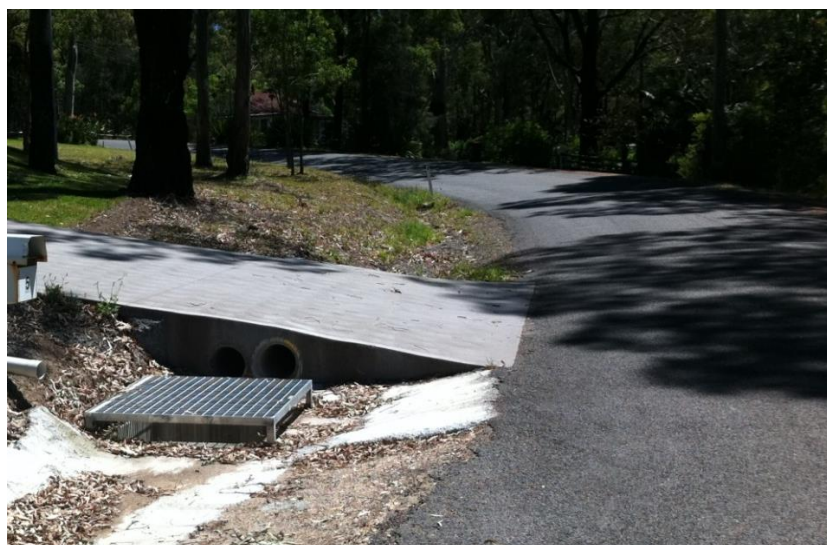
Figure 3-4 New Drainage Inlet Opposite 10 Cove Boulevard

Construction of a driveway associated with a new dwelling in the property opposite 10 Cove Boulevard has limited the stormwater flowing to a new stormwater inlet. The drainage inlet is connected to a piped drainage system through 10 Cove Boulevard. The pipe within 10 Cove Boulevard has been inspected by Council. The pipe is butt jointed which enables water to seep in through gaps at the joints. Recent CCTV inspection by GLC has confirmed that the pipe was not blocked, broken or excessively deflected at the time of this inspection.

The constructed driveway causes stormwater to back up the table drain effectively diverting most flows across the road. Smaller flows conveyed within the table drain upslope of the driveway are able to drain through the driveway crossing, but even modest flows are re-directed across the road. Re-directed stormwater flows down a relatively steep unsealed driveway in 10 Cove Boulevard. The owner has indicated that the driveway has been scoured by uncontrolled stormwater, necessitating reconstruction of the driveway on several occasions. Overland flow through this property then drains into North Arm Cove.

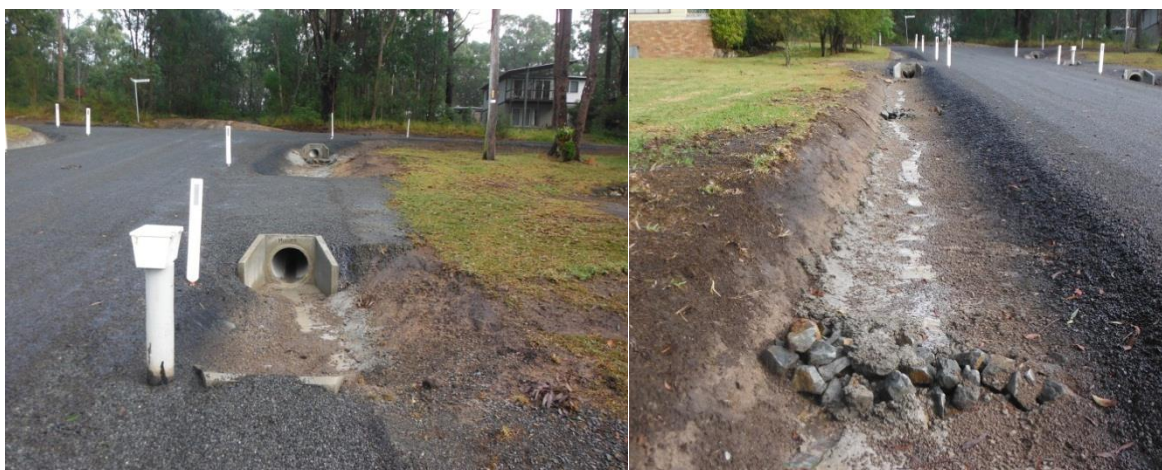
Figure 3-5 New Works in Upper Water Street

Water Street forms a key drainage flow path to North Arm Cove. The drainage system along Water Street has recently been reconstructed including formation of partially concrete lined table drains, new driveway crossings, new culverts and rock lined open channels. Residents have reported an improvement in drainage along the upper half of Water Street since the completion of the new drainage works. Examples of the new works in the upper half of Water Street are shown in Figure 3-5.

The main issue with the new works in the upper section is that the steep table drains are likely to require regular inspections to ensure that the integrity of the concrete lining is maintained and the drains are not eroded over time. Runoff from an existing unsealed track upslope of the new works also contributes elevated levels of sediment discharged into North Arm Cove.

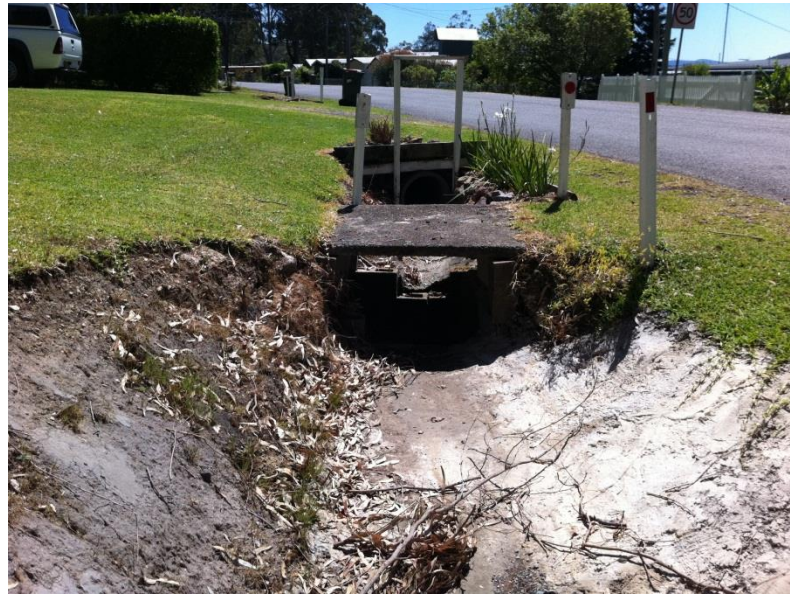
Figure 3-6 Drainage Inlet near Cove Boulevard / Water Street Intersection

The inlet opening to the piped drainage system under Cove Boulevard exceeds standards developed to ensure safety to the community. In particular, the current situation is considered to be **extremely** hazardous for children.

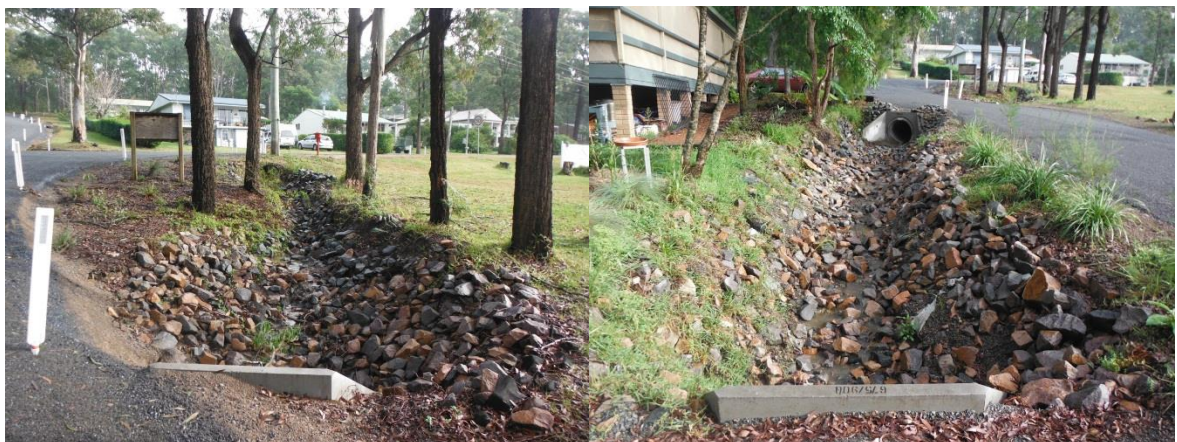
Figure 3-7 Upper and Middle Open Channel Reaches (looking upslope)

The lower section of the drainage system along Water Street below Cove Boulevard comprises three sections of new rock-lined channel separated by culverts under Water Street and a driveway crossing. Site observations indicate that the rock lining has been placed unevenly and may be insufficiently sized for the flow velocities along the channel. The lower section of the channel below the driveway crossing appears to have been constructed with a face angle that is too steep to maintain stability of the rock lining. Combined with the small rock size, this has resulted in parts of the channel rock lining collapsing and the liner protecting the bare channel sides also dropping into the channel (refer Figure 3-8). The banks in this lower area are now highly susceptible to erosion from stormwater and tidal movements and eroded sections of the channel are suspected of encroaching on the adjacent private property.

Rock lining dislodged and discharged into the foreshore area is considered hazardous by the community who use this area for launching dinghies and for children to swim. The community has suggested that the concentrated stormwater discharge has seriously impacted on sea grasses in the area.

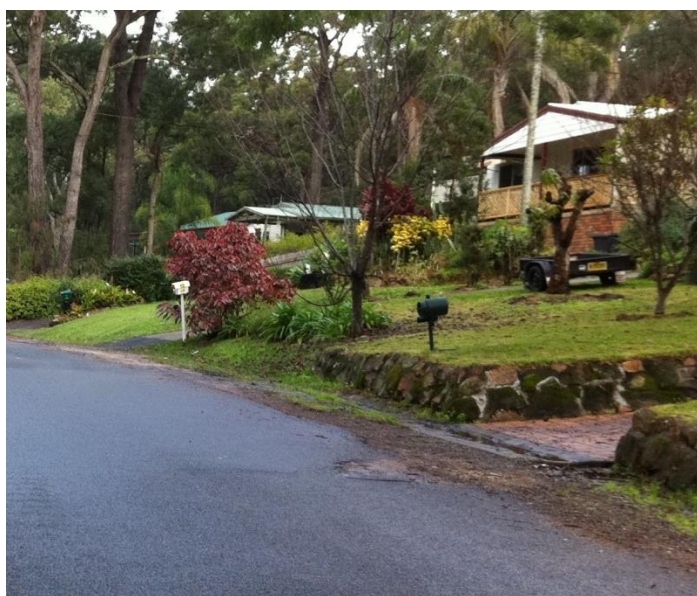
Figure 3-9 Existing Road Condition Near 49 Cove Boulevard

Site 2c – 49 Cove Boulevard to Water Street. A number of residents have observed runoff discharging across the road near the existing road crest in front of 49 Cove Boulevard. Residents have also indicated that seepage continues across the road for several days after conclusion of significant wet weather. The runoff then drains into properties on the low side of Cove Boulevard causing nuisance to residents in these lots. There is currently no table drain or other drainage system on the high side of Cove Boulevard to intercept this runoff before it overtops the road. The adverse road cross fall also leads to runoff being directed into the low side lots.

It appears that the construction of Cove Boulevard at this location is functioning similarly to a dam, restricting the flow of shallow groundwater in a direction towards North Arm Cove. Shallow groundwater is potentially backing up behind the road pavement prior to resurfacing and flowing across the road. Driveways are also regarded as preferential paths for runoff and the longer term seepage. This shallow seepage groundwater continues to flow slowly down the slope for several days after rain. The road pavement has deteriorated at this location, providing further evidence that sub-surface water potentially may be weakening the pavement.

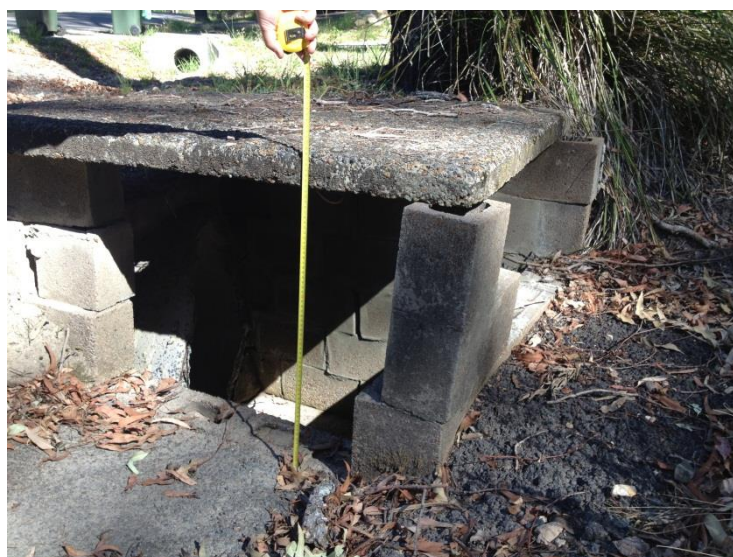
Figure 3-10 Drainage Inlet Opposite 70 Cove Boulevard

An existing drainage structure is located at a low point on the high side of the road opposite 70 Cove Boulevard. This drainage structure appears to be in poor condition and the size of the opening exceeds standards and is considered to be **extremely** hazardous to the community. The pit discharges to a 900mm diameter concrete pipe that drains into 70 Cove Boulevard adjacent to the boundary and conveys runoff to North Arm Cove. Unfortunately, the 900mm diameter pipe reduces to a 500mm diameter uPVC pipe at a drainage pit located within 70 Cove Boulevard. This pipe is located of 70 Cove.

The drainage line transition from a 900mm to 500mm diameter pipe creates a potential choke point in this system, where larger debris able to enter the pipe through the existing large inlet (refer Figure 3-10) potentially can become blocked at the inlet to the 500mm diameter pipe. Ensuring large debris does not enter the 900mm diameter pipe is important for maintaining the integrity of this system. The pipe size reduction also encourages system overflows based on downstream capacity alone.

Residents have recorded that the pit inlet across from 70 Cove Boulevard can become blocked with organic debris during rainfall events. When the pit inlet becomes blocked, or the capacity of the downslope drainage system is exceeded, stormwater over tops the road and drains overland through 70 Cove Boulevard.

It is recommended that Council consider completing CCTV inspections of all larger drainage pipes and culverts that discharge into North Arm Cove to ensure that the pipes are not blocked, damaged or out of alignment. A priority drainage line for inspection is the system through 70 Cove Boulevard.

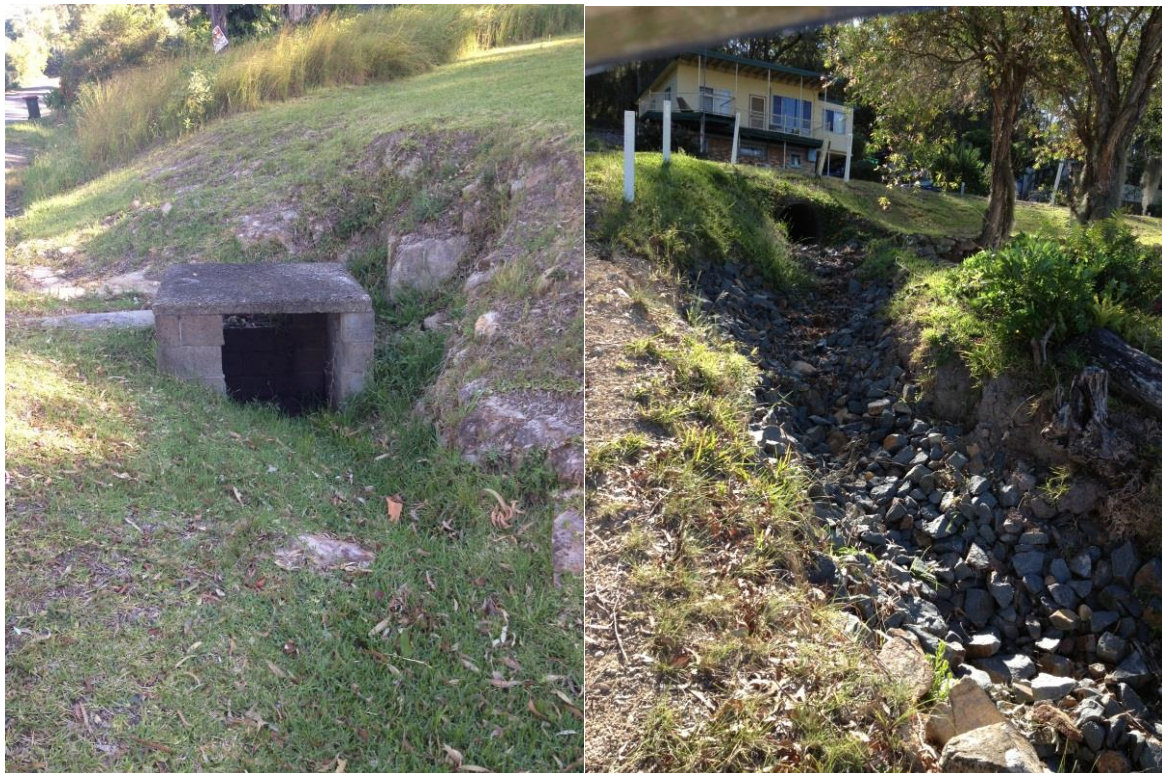
Figure 3-11 Drainage Inlet Opposite 108 Cove Boulevard and Rock Lined Channel

Drainage in this area is primarily influenced by table drains located on the high side of the road. These table drains have been constructed to convey stormwater runoff to an existing drainage pit opposite 108 Cove Boulevard. This drainage pit is connected to a pipe that conveys stormwater across Cove Boulevard and discharges into a steep rock lined channel aligned along the southern boundary of 108 Cove Boulevard. The existing drainage pit inlet opening exceeds standards and would be hazardous for the community. The rock-lined channel is steep and would also be hazardous to the community. The rock lining is collapsing in areas and the channel actively eroding due to high velocity flows. Rocks are also being dislodged and conveyed by fast flowing stormwater into North Arm Cove. The current condition of the drainage pit and rock lined channel is shown in Figure 3-11.

Video footage taken by residents during the March 2013 event shows that a significant proportion of runoff draining from the north overtopped the road opposite 104 Cove Boulevard and drained overland through this lot prior to reaching the drainage pit opposite 108 Cove Boulevard. The overland flow was highly turbid. Residents also observed runoff draining from the south spilling across the road near 99 Cove Boulevard and draining overland towards 110 Cove Boulevard.

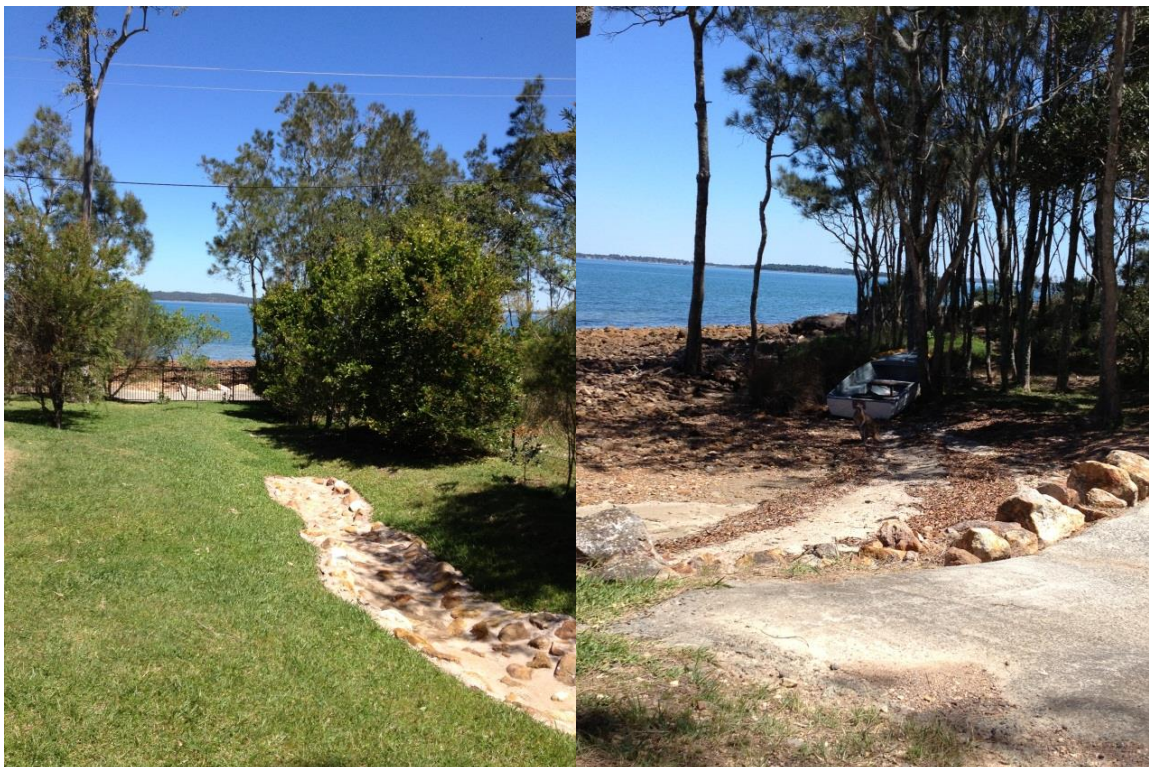
Figure 3-12 Existing Concrete Lined Overland Flowpath and Causeway at 33 The Esplanade

The recent significant runoff event in March 2013 resulted in high velocity and deep overland flow through the property causing damage to the landscaped areas. The property owner advised that some of the damaged landscaping areas were replaced with harder concrete lined sections to reduce damage occurring in future events (refer Figure 3-12).

A concrete lined causeway is located at the end of The Esplanade adjacent to the site (refer Figure 3-12). The community has identified potential hazardous conditions during large rainfall events associated with flow over this causeway. There is potential that the depth and velocity of stormwater discharging to the foreshore will be a safety hazard, especially to young children as the site provides public access to the waterfront. Similar hazards are likely to exist within the property upslope of the causeway.

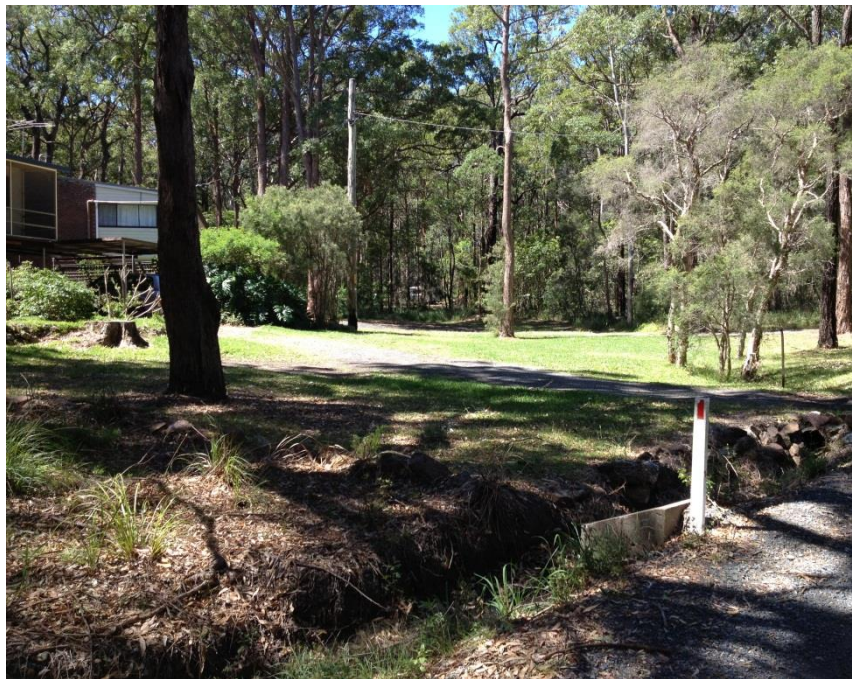
Figure 3-13 Northern Table Drain and Driveway Access to 51 The Esplanade

A significantly large undeveloped catchment drains along a flow path that crosses the driveway access to 51 The Esplanade. The property owner has advised this has resulted in regular stormwater damage to the driveway and nuisance due to the driveway access to the property being impeded by the overland flows. Only very small flows are capable of being conveyed under the driveway through a 375mm diameter pipe into an adjacent table drain.

The existing table drain and culverts located on the northern side of The Esplanade adjacent to the property are not currently functioning efficiently. Stormwater overtopping the driveway access would currently primarily flow across The Esplanade into the drainage swale on the southern side. A high proportion of the overland flow would currently bypass the existing table drain.

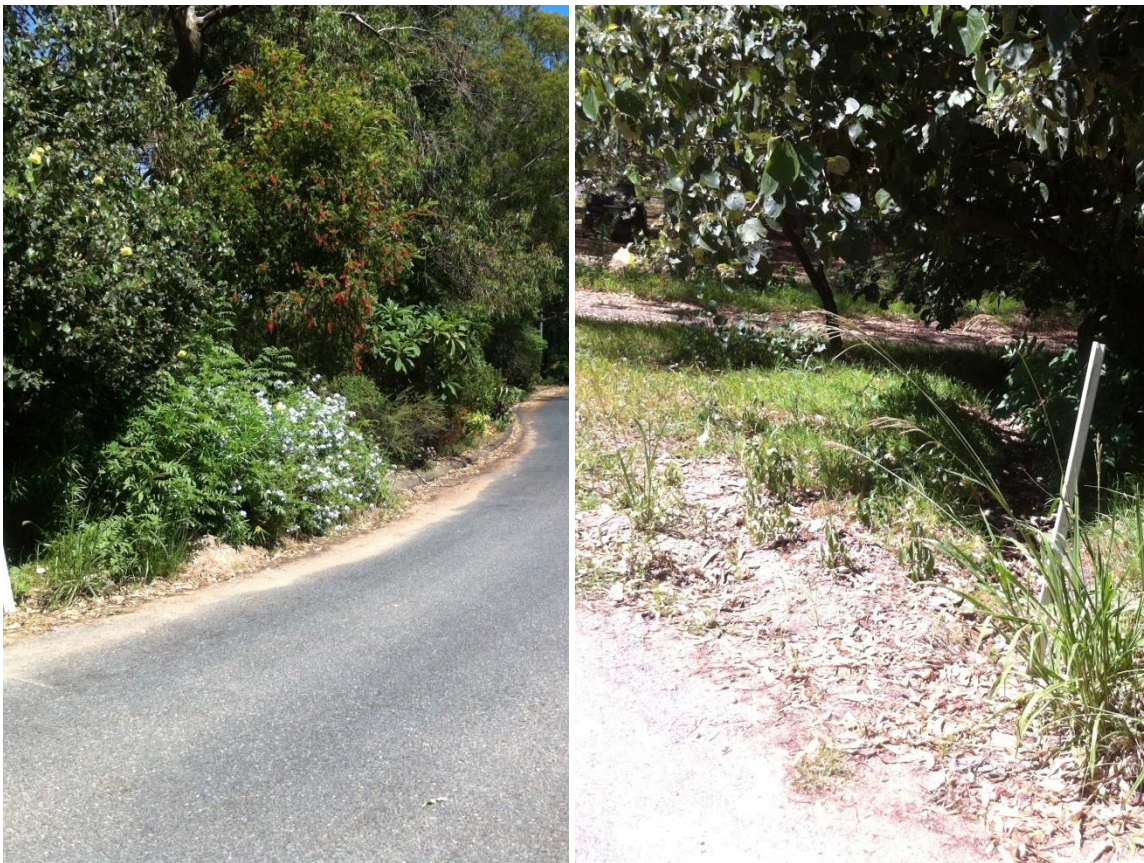
Figure 3-14 Raised Roadside Kerb and Resulting Overland Flow Path at 91 Promontory Way

The residents at 91 Promontory Way have advised Council that there are continuing issues with the drainage at this location. Residents have reported that during any rain event runoff washes parts of their gravel driveway away. During a recent large storm this drainage issue resulted in internally flooding of their garage. The raised kerb on the low side of Promontory Way stops at the boundary between 89 and 91 and appears to result in runoff from the road draining onto the residents driveway, a flow path from the road through to the residents driveway can be seen in Figure 3-14. This combined with excess water overflowing from the drainage pit and flowing through 91 Promontory Way has resulting in scouring of the driveway.
