APPENDIX D: AVAILABLE BOREHOLE LOGS FOR OLD BAR BEACH

OLD BAR COASTAL EROSION STUDY

SINCLAIR KNIGHT & PARTNERS PTY. LTD. CONSULTING ENGINEERS

**OLD BAR
SEWERAGE**

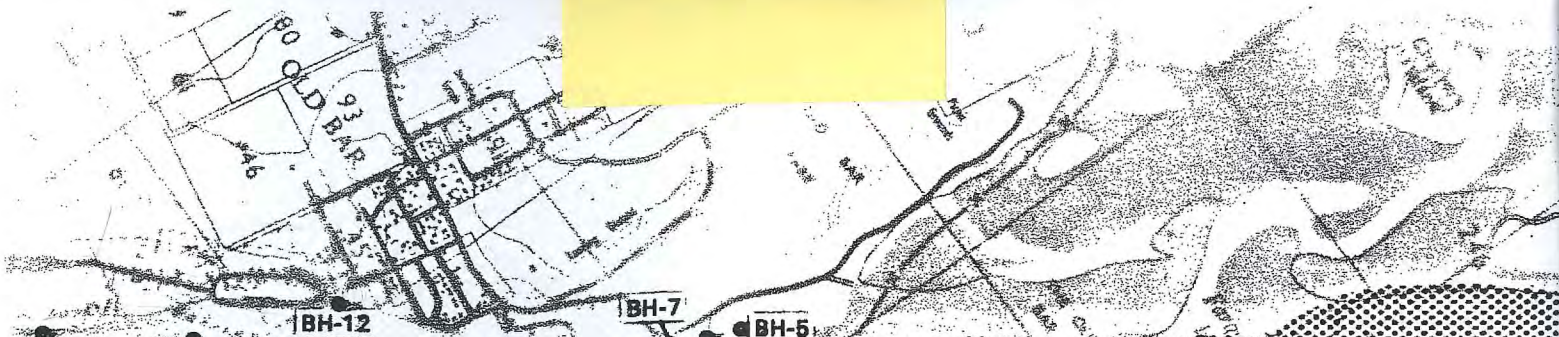
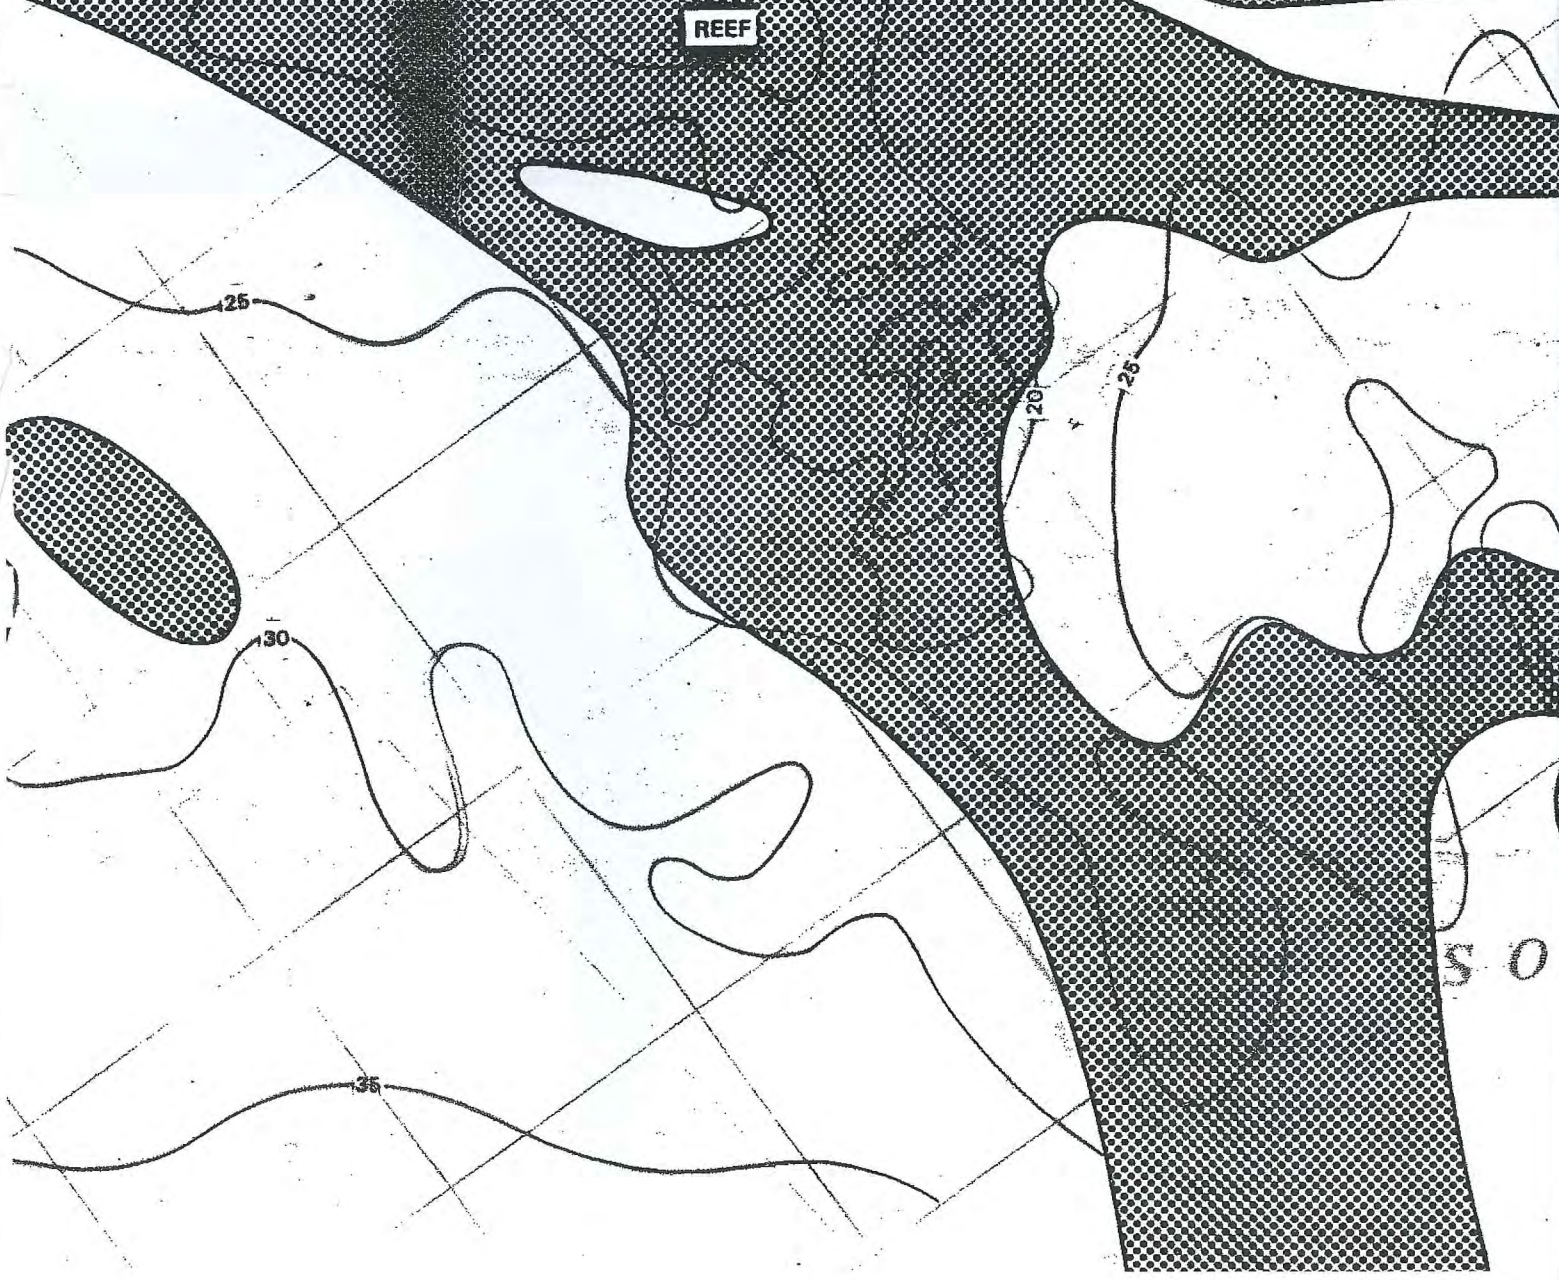
BH-4 BH-3 BH-11 BH-2 BH-1 BH-9 BH-8 BH-7 BH-6 BH-5

TABLE B.3 - FIELD NOTES FROM BEACH AUGERING SITES

Note: Depths are given in metres relative to ISLW and locations are shown on **Figure 14**.
