**Waterway &
Catchment
report**

Great Lakes Council 2014 Waterway and Catchment Report

Great Lakes Council
Natural Systems and Estuaries Section

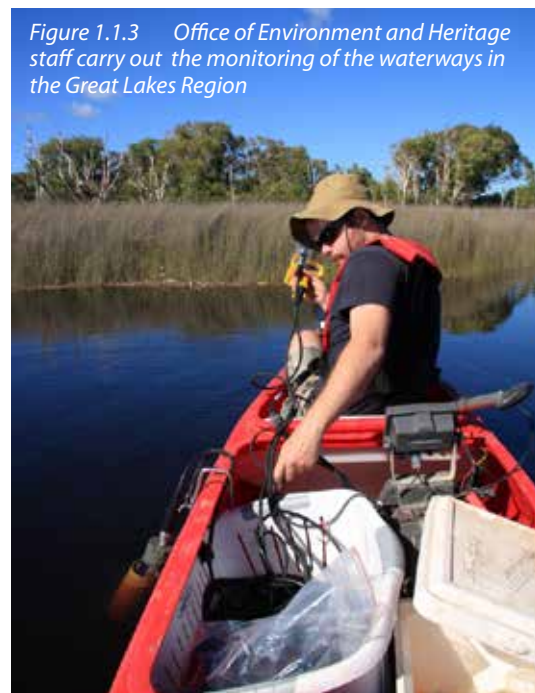
Figure 1.1.3 Office of Environment and Heritage staff carry out the monitoring of the waterways in the Great Lakes Region

At each of the selected sites, samples were taken in accordance with the NSW Monitoring, Evaluation and Reporting protocols which are described in full in Roper et al. (2011). At each of the "Lake" sites, turbidity was measured using a calibrated probe suspended at a depth of 0.5 metres for five minutes as the boat drifted or was motored (generally covering a distance of at least 300 metres), logging data every 15 seconds. The final value for the "site" sampled was the average of all the logged data. During the drift, at least five samples of the top 1m of the water column

were collected and combined in a bucket. At the end of the drift, a single 200 millilitre sample for chlorophyll a analysis was taken from the composite in the bucket.

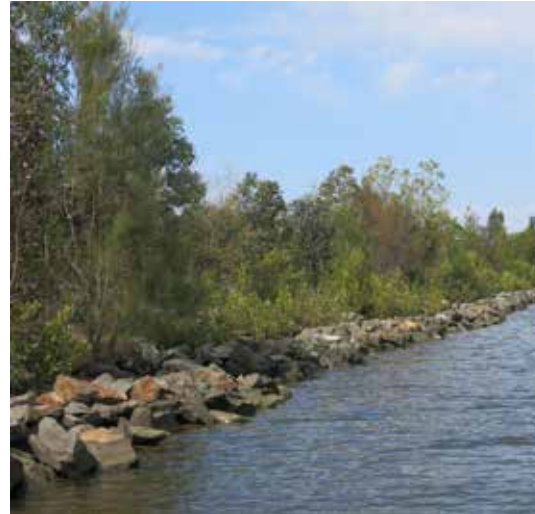
Figure 1.1.18 Rock fillets encourage the establishment of mangroves

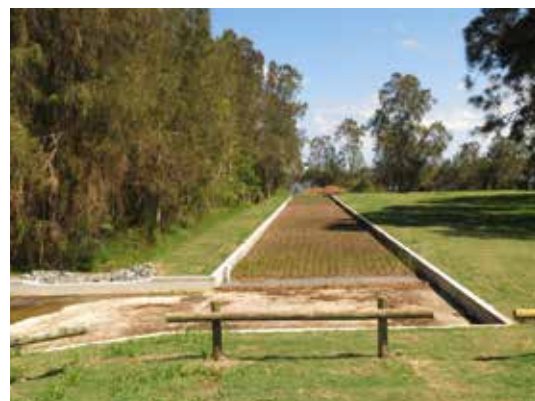
Over the past five years Great Lakes Council have been building water quality gardens in the Pipers Creek Catchment to filter the sediments and nutrients out of the stormwater prior to flowing out into Wallis Lake. Six gardens have been built in the Palms Estate drainage reserve between Kularoo Drive and the Southern Parkway. An additional garden was built out the front of Council on Breese Parade as a demonstration, filtering water from the road, further protecting Pipers Creek. In 2013, another water quality garden was constructed at the Forster campus of Great Lakes College, the number of gardens constructed now totals eight (8). A ninth water quality garden is currently under construction on the corner of Pipers Bay Drive and Tahiti Avenue. The water quality gardens work by slowing down the stormwater so that large particles like soil drop out of suspension. The water then flows over a planted area and the microscopic alga (biofilms) which grow on the plant roots remove the nutrient nitrogen. The sandy loam soil that the plants grow in also acts as an additional filter removing other pollutants like heavy metals, petrochemicals and phosphorus. The water that then flows into the stormwater drain is cleaner prior to flowing into Wallis Lake.

Figure 1.1.20 Pipers Bay Drive water quality garden (under construction)

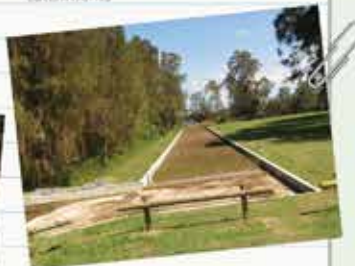
WATER SENSITIVE URBAN DESIGN

9 water quality gardens and two wetlands built to treat 39.6 ha of land in the Pipers and Muddy Creek catchments

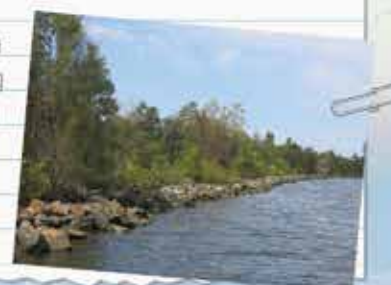
BANK STABILISATION

Stabilising 5.1 km of the Wallamba River with rock protection, planting 9170 native plants and conserving 9.5km of stream bank

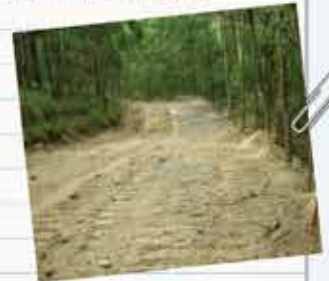
EROSION CONTROL

120km roads and trails closed, rehabilitated and maintained to reduce erosion and sedimentation in Myall Lakes National Park

In the areas where the roads were closed, signs, gates and bollards were constructed, trees were left across the track and the surface of the land was roughened to promote vegetation growth. These areas have begun to revegetate naturally. Outside of the National Park, erosion hot spots on gravel roads in the catchment have begun to be addressed. On Old Inn Road a concrete causeway was constructed across the Wild Cattle Creek along with sealing of the road on the approaches to the creek combined with geofabric and rock lining of the table drain significantly reducing sediment loads and turbidity to the creek.

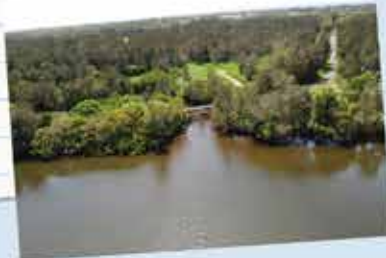
DARAWAKH CREEK AND FROGALLA SWAMP

This 1000ha wetland was identified as a key source of acid flowing into the Wallamba River from historical agricultural drainage works. Restoration works commenced in 2003 including removal of drains and a tidal headwall, weed control and revegetation as well as incorporation of key wetlands into the existing Darawank Nature Reserve. Significant improvements in downstream water quality have since been achieved as well as the restoration and conservation of biodiversity.

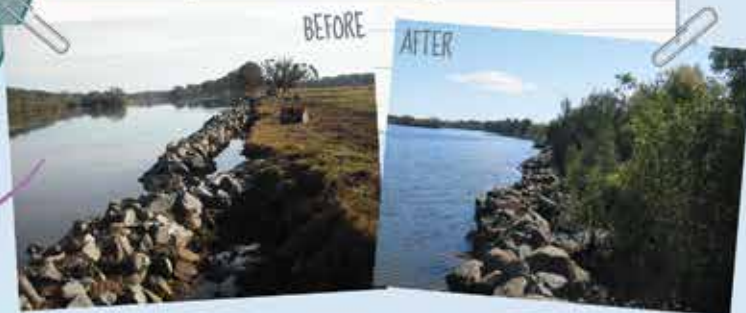
RIVERBANK PROTECTION AND RESTORATION WORKS

To protect and reinforce riverbanks from erosion rock revetment walls have been installed along high-risk sites. Rock fillets have also been installed to assist mangroves regenerate along eroding riverbanks and riparian areas have been replanted with native vegetation.

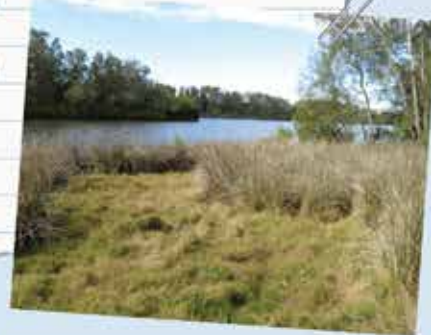
GEREEBA AND WALLAMBA ISLAND RESTORATION PROJECT

Works are currently occurring on Gereeba and Wallamba Island wetlands to restore the islands' biodiversity as well as the important services their wetlands provide. Activities on the island include fox and wild dog control, weed removal and native replanting. This project has involved multiple partners including the Environmental Trust, Biodiversity Fund, OEH and an innovative project with Greenfleet to sequester carbon through replanting of native vegetation.
