2012 waterway & catchment REPORT CARD

for Wallis & Myall Lakes & Karuah Estuary

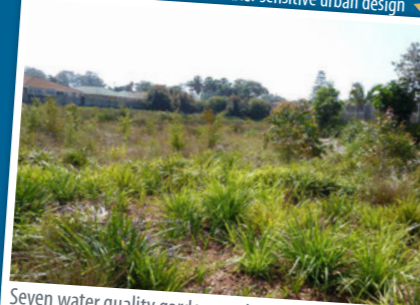
Water sensitive urban design

Seven water quality gardens and two wetlands built to treat 36 hectares of land in the Pipers and Muddy Creek Catchments

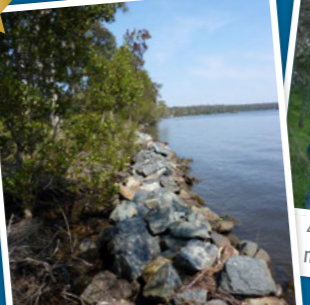
Bank stabilisation

Stabilising 4.2km of the Wallamba River with rock protection, planting 8,000 native plants and conserving 8.6km of streambank

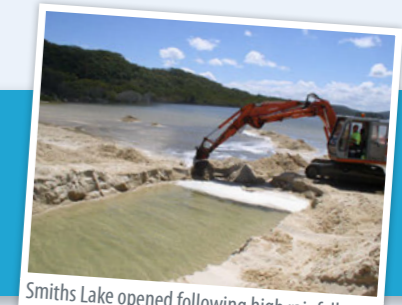
Smiths Lake opened following high rainfall, December 2011
