# 2014 Waterway & Catchment reportcard

for Wallis and Myall Lakes  
and the Karuah Estuary

# Spotlight on the Wallamba River estuary

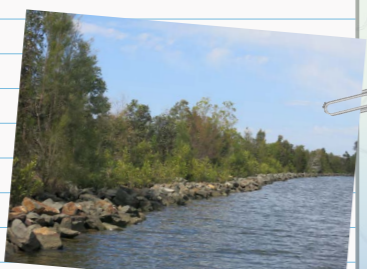
### BANK STABILISATION

Stabilising 5.1 km of the Wallamba River with rock protection, planting 9170 native plants and conserving 9.5km of stream bank

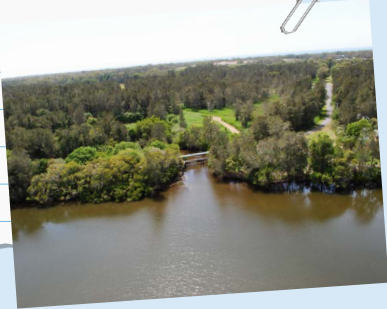
## DARAWAKH CREEK AND FROGALLA SWAMP

This 1000ha wetland was identified as a key source of acid flowing into the Wallamba River from historical agricultural drainage works. Restoration works commenced in 2003 including removal of drains and a tidal headwall, weed control and revegetation as well as incorporation of key wetlands into the existing Darawank Nature Reserve. Significant improvements in downstream water quality have since been achieved as well as the restoration and conservation of biodiversity.

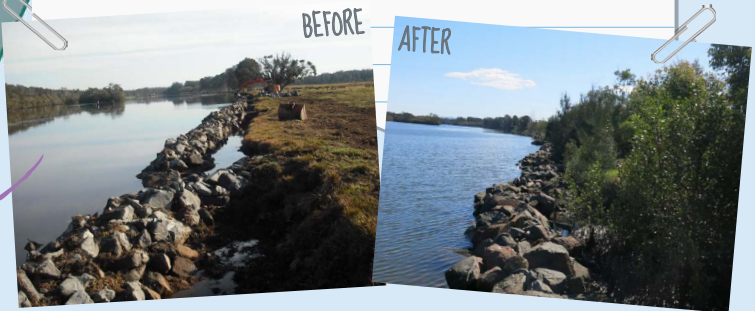
## RIVERBANK PROTECTION AND RESTORATION WORKS

To protect and reinforce riverbanks from erosion rock revetment walls have been installed along high-risk sites. Rock fillets have also been installed to assist mangroves regenerate along eroding riverbanks and riparian areas have been replanted with native vegetation.
