**waterway &  
catchment  
report**

Great Lakes Council 2013 Waterway and Catchment Report

Great Lakes Council  
Natural Systems and Estuaries Section

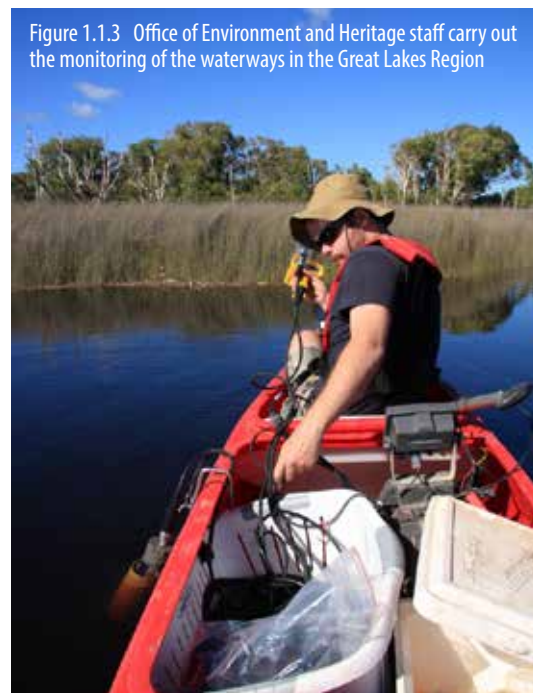
Figure 1.1.3 Office of Environment and Heritage staff carry out the monitoring of the waterways in the Great Lakes Region

At each of the selected sites, samples were taken in accordance with the NSW Monitoring, Evaluation and Reporting protocols which are described in full in Roper et al. (2011). At each of the "Lake" sites, turbidity was measured using a calibrated probe suspended at a depth of 0.5 metres for five minutes as the boat drifted or was motored (generally covering a distance of at least 300 metres), logging data every 15 seconds. The final value for the "site" sampled was the average of all the logged data. During the drift, at least five samples of the top 1m of the water column were collected and combined in a bucket. At the end of the drift, a single 200 millilitre sample for chlorophyll a analysis was taken from the composite in the bucket.

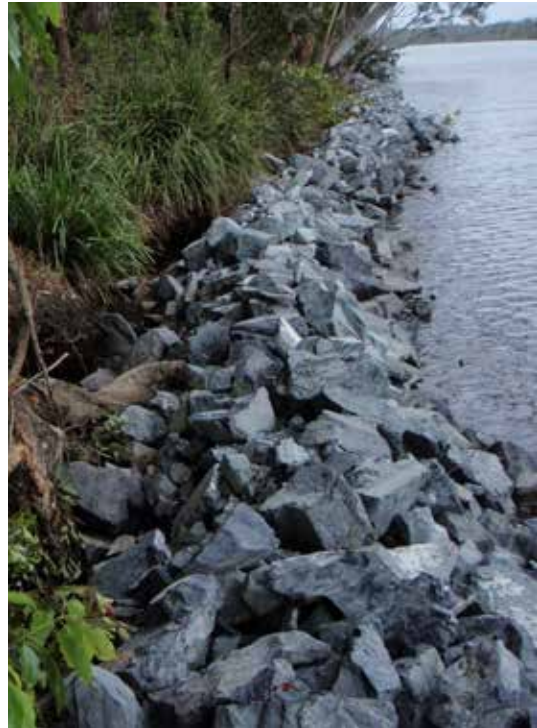
Figure 1.1.9 Erosion protection works on the Wallamba River

The Wallamba River Memorandum of Understanding brokered an innovative agreement to the management and remediation of these significant riverbank erosion issues affecting the banks of the lower Wallamba River. The MOU was amended in 2010 to address the increasing impact of wash from wake enhancing activities. The MOU amendments were negotiated with key stakeholders including caravan park businesses, landholders, waterway users and government agencies. Importantly, the amendments provide a designated area for wakeboarding and other wake enhancing activities within Wallis Lake in an area

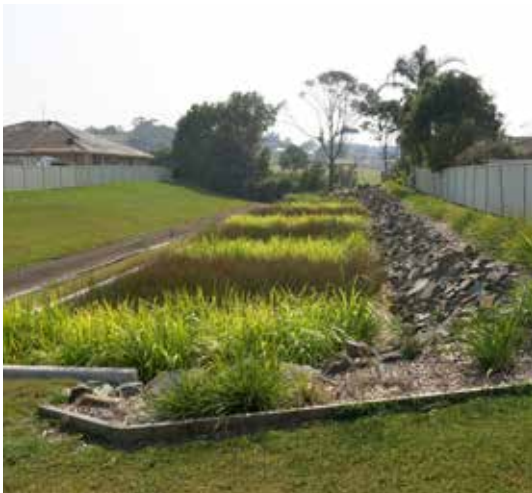
Figure 1.1.11 Palms Estate water quality garden

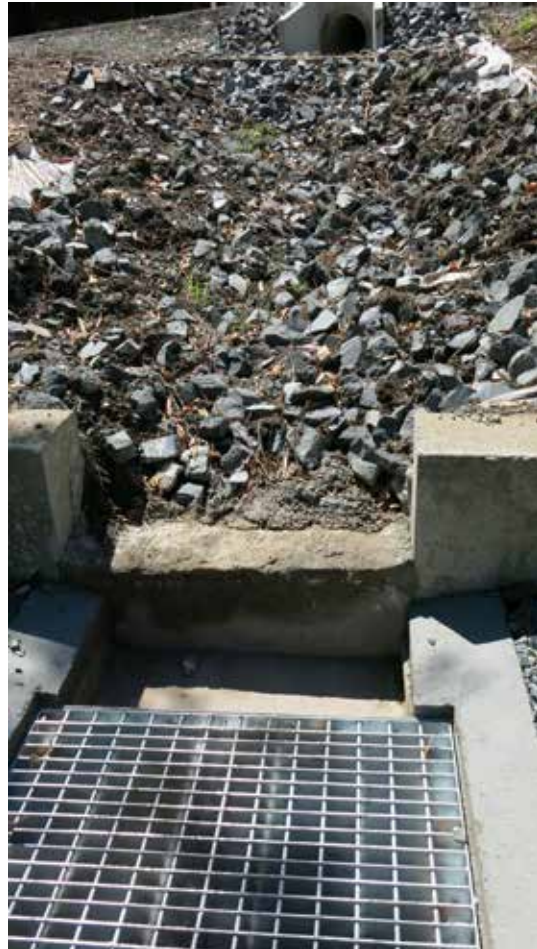
Figure 1.1.14 Rock lined drain and inlet pit at Tarbuck Bay

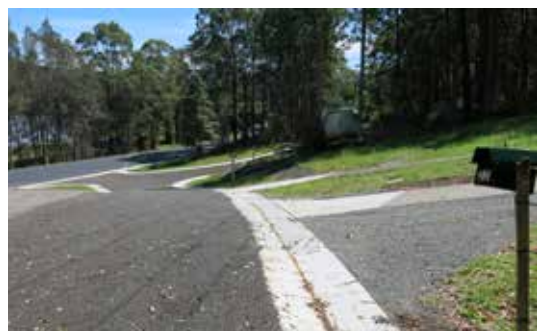
Figure 1.1.15 Gravel road sealing and table drain upgrade, Tarbuck Bay

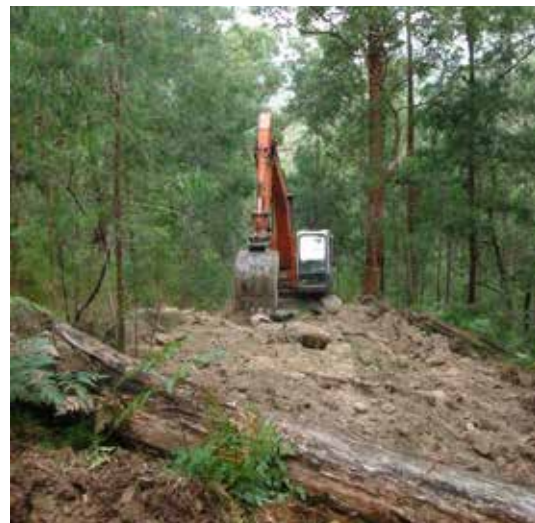
Figure 1.1.16 Closure and rehabilitation of trails in the Myall Lakes National Park
