Waterway &
Catchment
report

Great Lakes Council 2015 Waterway and Catchment Report

Great Lakes Council
Natural Systems and Estuaries Section

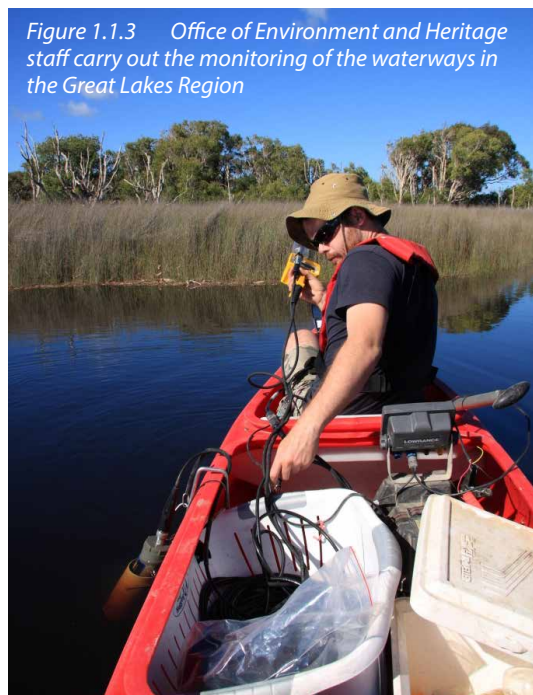
Figure 1.1.3 Office of Environment and Heritage staff carry out the monitoring of the waterways in the Great Lakes Region

At the end of the drift, a single 200 millilitre sample for chlorophyll a analysis was taken from the composite in the bucket.

For the river estuary sites, an 'underway sampler' is used to pass water past the probe whilst the boat travels at a regulated speed along a transect upstream from the middle to the upper part of the estuary. The turbidity is calculated as the mean of logged values for the transect. At two sites along the transect, composite water samples are collected for chlorophyll a analysis.

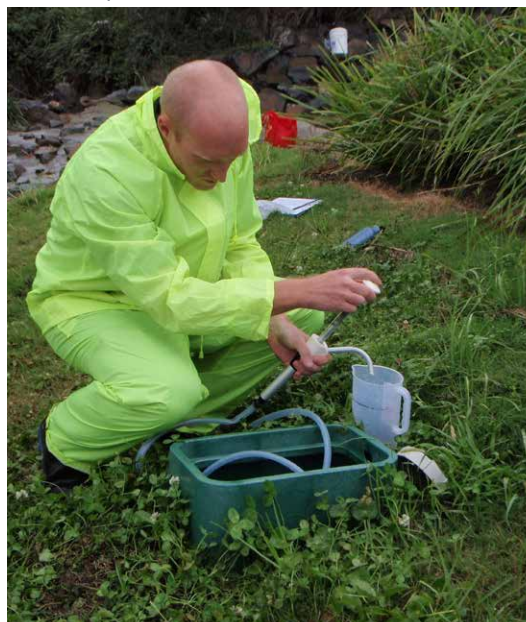
Figure 1.1.6 Great Lakes Council staff collecting water samples

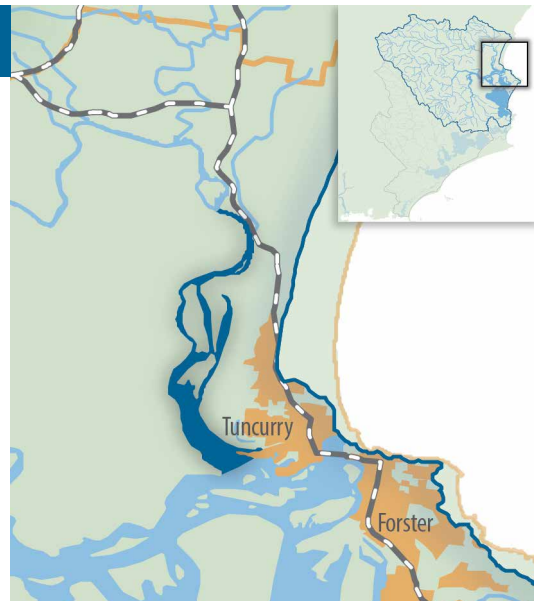
Mid Wallamba Estuary

Waters of the Mid Wallamba have remained clear most of the time, but the amount of algae in the water continues to be higher than desired. Nutrients from the catchment combined with clear waters and the still, hot conditions led to overall high concentrations of algae.

The weather conditions were ideal for algae, with the heavy rain bringing nutrients into the river and clear warm waters combining to stimulate growth. Algal abundance (chlorophyll) exceeded the trigger values every time it was measured, and those exceedances were moderately large (20% of the worst value). Unhealthy growth of small algae in the waters is stimulated by nutrients washed from urban areas and pastures, or from stock directly accessing waterways. If this continues, then algae may reach levels in the water which are detrimental to fish, humans and livestock. Even though the rainfall was less this year, the clear waters provide plenty of light and this combines with the nutrient loads to grow undesirable amounts of algae.

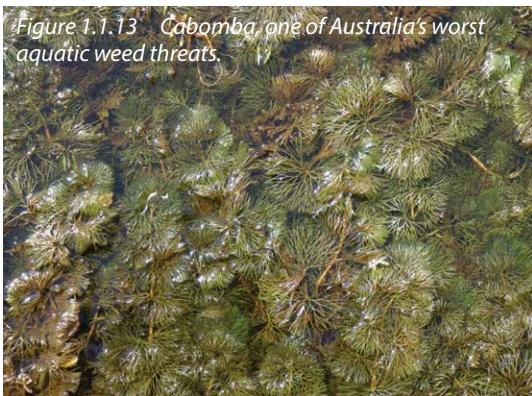
Sixteen hectares of Cabomba infested waterways were monitored in the Wallis Lake catchment to evaluate the effectiveness of a two-year federally funded Cabomba eradication project. The project complements another federally funded project to conduct trials, leading to the registration of a suitable herbicide for the effective control of Cabomba. The program identified that 5.5 hectares were in need of retreatment. The retreatments formed part of ongoing maintenance jointly funded through Great Lakes Council's Noxious Weeds Program and the federal government's Caring for our Country Program. The maintenance program commenced in July 2013 with ongoing monitoring and any subsequent re-treatments being conducted as deemed necessary leading to the longterm goal of eradication.

Figure 1.1.13 Cabomba, one of Australia's worst aquatic weed threats.

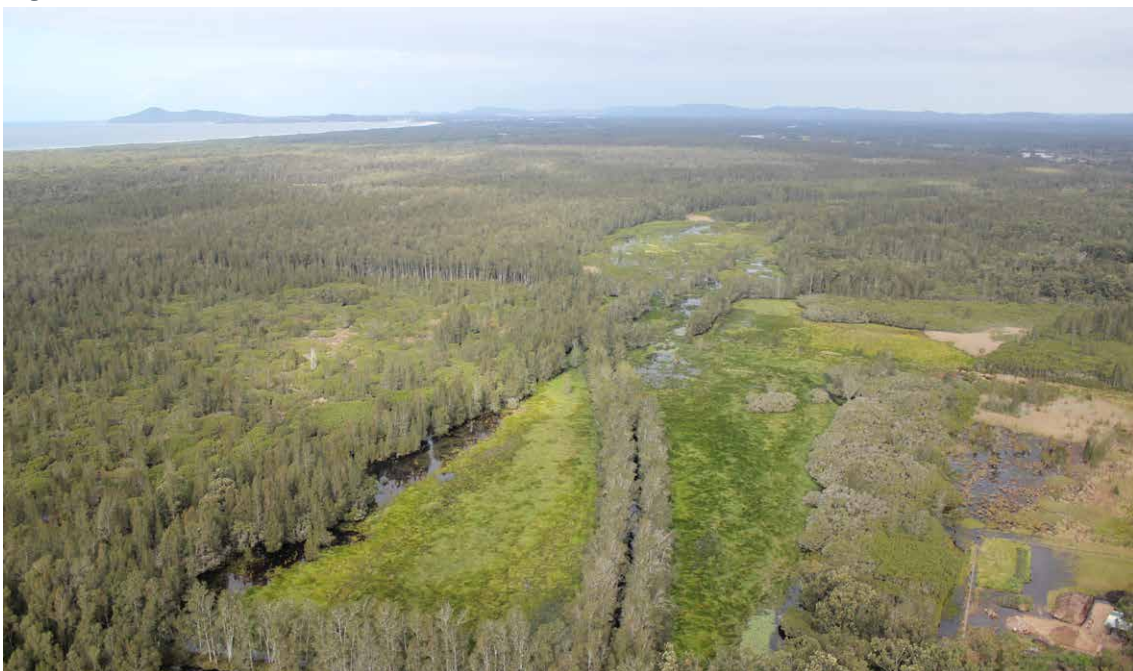
Figure 1.1.14 Darawakh Wetland.

Council has also restored pre-disturbance hydrology to over 90% of the Darawakh Creek/ Frogalla Swamp through the infilling or decommissioning of 22.2 kilometres of artificial drains and removal of 1.5 kilometres of artificial levees to remediate a significant acid sulfate floodplain wetland system. Monitoring has indicated that the works are having measurable success regarding the protection of the Lower Wallamba River from toxic acid and metal discharges. Further, there has been substantial biodiversity outcomes associated with the program.

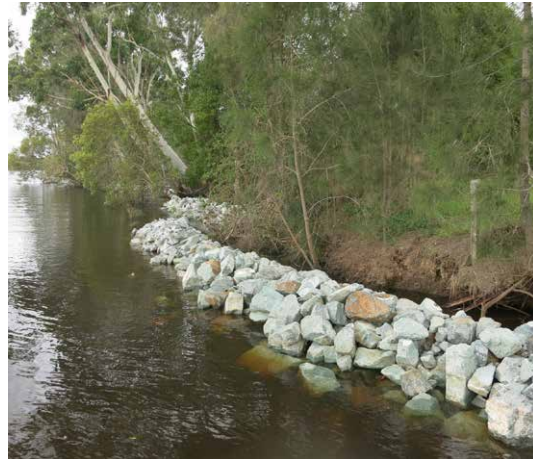
Figure 1.1.15 Rock fillets along the Wallamba River.

A total of 6.5 kilometres of the Wallamba River has been stabilised with rock protection and 10,170 native plants have been planted (including 1,000 in 2014-2015). Ongoing bush regeneration and maintenance conserves 10.9 kilometres of streambank.

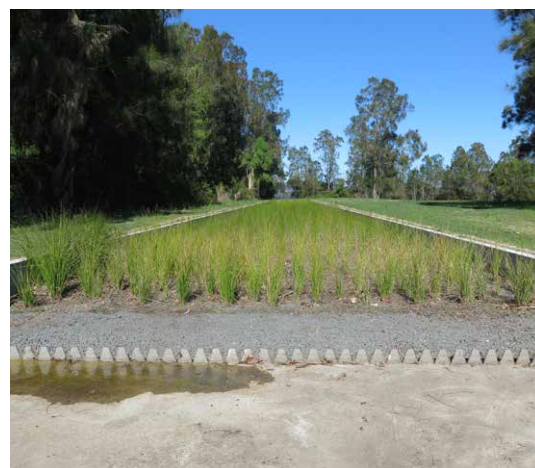
Figure 1.1.17 Pipers Bay Drive water quality garden.

Over the past five years Great Lakes Council have been building water quality gardens in the Pipers Creek catchment to filter the sediments and nutrients out of the stormwater prior to flowing out into Wallis Lake. Six gardens have been built in the Palms Estate drainage reserve between Kularoo Drive and the Southern Parkway in Forster. An additional garden was built out the front of Council on Breese Parade as a demonstration, filtering water from the road, further protecting Pipers Creek. In 2013, another water quality garden was constructed at the Forster Campus of Great Lakes College. The construction of the ninth water quality garden on the corner of Pipers Bay Drive and Tahiti Avenue, Forster was completed in August 2014. The number of gardens constructed now totals nine. The water quality gardens work by slowing down the stormwater so that large particles like soil drop out of suspension. The water then flows over a planted area and the microscopic alga (biofilms) which grow on the plant roots remove the nutrient nitrogen. The sandy loam soil that the plants grow in also acts as an additional filter removing other pollutants like heavy metals, petrochemicals and phosphorus. The water that then flows into the stormwater drain is cleaner prior to flowing into Wallis Lake.

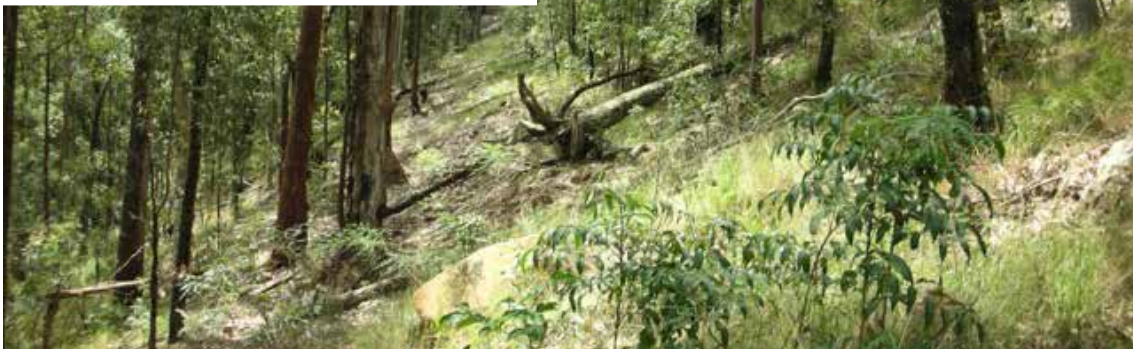
Figure 1.1.20 Trail in Myall Lakes National Park showing regrowth is occurring after trail closure.

In an effort to reduce erosion and sedimentation in the Myall Lakes catchment, the New South Wales National Parks Service have rehabilitated, maintained or closed 59 kilometres in the Myall Lakes catchment since 2008. Outside of the National Park, erosion hot spots on gravel roads in the catchment have begun to be addressed. On Old Inn Road a concrete causeway was constructed across the Wild Cattle Creek along with sealing of the road on the approaches to the creek combined with geofabric and rock lining of the table drain significantly reducing sediment loads and turbidity to the creek.
